**Subject: Review of Supplemental Data Geologic Hazards Evaluation AJ Rock LLC Property  
6695 South Wasatch Boulevard Cottonwood Heights, Utah (October 4, 2020)**

**Review of Geologic Hazards Evaluation AJ Rock LLC Property  
6695 South Wasatch Boulevard Cottonwood Heights, Utah (May 11, 2020)**

**Review of Surface Fault Rupture Hazard Evaluation AJ Rock LLC Property  
6695 South Wasatch Boulevard Cottonwood Heights, Utah (October 8, 2018)**

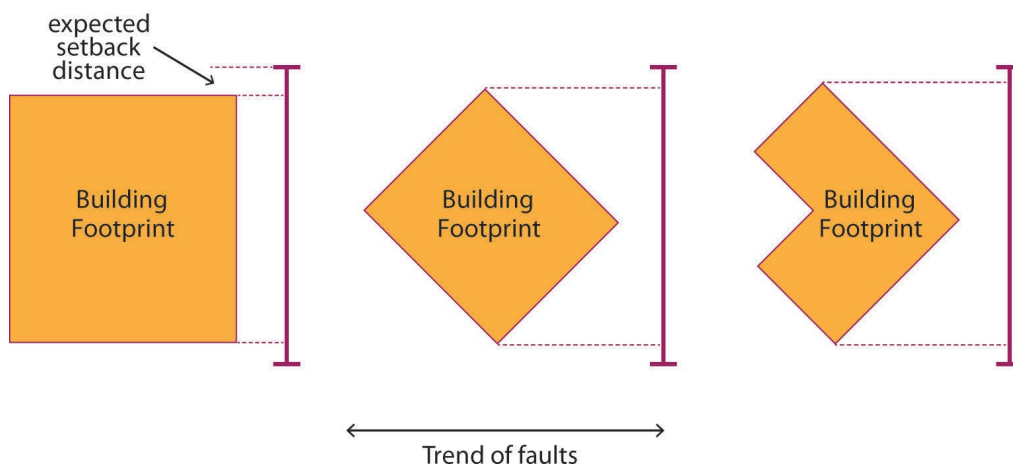
**Figure 15.** Fault trench length and orientation to investigate a building footprint. Trenching must extend beyond the footprint of at least the expected setback distance for the IBC Building Risk Category class (from Christenson and others, 2003).

It should be noted that the setback areas as shown on Figure 4 are delineated around the mapped locations of the surface rupture faults as shown on Figure 4. In Bowman and Lund (2016) Chapter 3 Guidelines for Evaluating Surface-Fault-Rupture Hazards in Utah, under the section heading Fault Mapping, subsection heading Trench Number and Location (page 44) it states: “...Trenches should be oriented perpendicular, or as close to perpendicular as possible, to the trend of the mapped fault trace at or near the site, and be of adequate length to intercept faults projecting toward proposed or existing structures and potential setback areas....”

Based on the recommended practice as described by Bowman and Lund (2016), trenching must extend beyond the proposed footprint of planned structures at least the distance of the expected or calculated setback distance. This means that the setback areas as shown on Western Geologic’s Figure 4 should extend in from the ends of the trenches into the trench the distance of the calculated setback distance. The boundaries of the setback areas and buildable area as shown on Western Geologic’s Figure 4 should be determined considering the UGS recommendation that trenching must extend beyond the footprint of each proposed structure a distance of at least the expected setback distance for the IBC Building Risk Category class (from Christenson and others, 2003) as shown above on the Bowman and Lund (2016) Figure 15. Setback areas and buildable areas for each proposed structure should be established in accordance with the method described by Bowman and Lund (2016) as part of the final surface fault rupture hazard assessment of each proposed structure. We recommend that the Cottonwood Heights City require Western Geologic to delineate surface fault rupture setback areas and buildable areas for the subject site on an updated Figure 4 in accordance with the method described by Bowman and Lund (2016).
